TRIP REPORT VILLAGE SAFE WATER

REPORT DATE: June 21, 2005 **REPORTER:** Greg Magee, P.E., VSW
TRIP DATE: March 25, 2005
LOCATION: Emmonak, Alaska **PROJECT NO:** N/A
PURPOSE: Mechanical and Electrical Inspections and Follow-up Evaluation of the Foundation of the New Washeteria
Accompanied by: Cindy Roberts, Denali Commission
John Faschan, P.E., EDC (Electrical Engineer)
Kevin Hanson, P.E., EDC (Mechanical Engineer)
Brian Shumaker, P.E., Duane Miller & Associates

Subject: Additional Post-Construction Geotechnical Consultation
New Washeteria Building
Emmonak, Alaska
DM&A Job No. 4135.006

Subject: Emmonak Washeteria – Site Inspection Trip Report

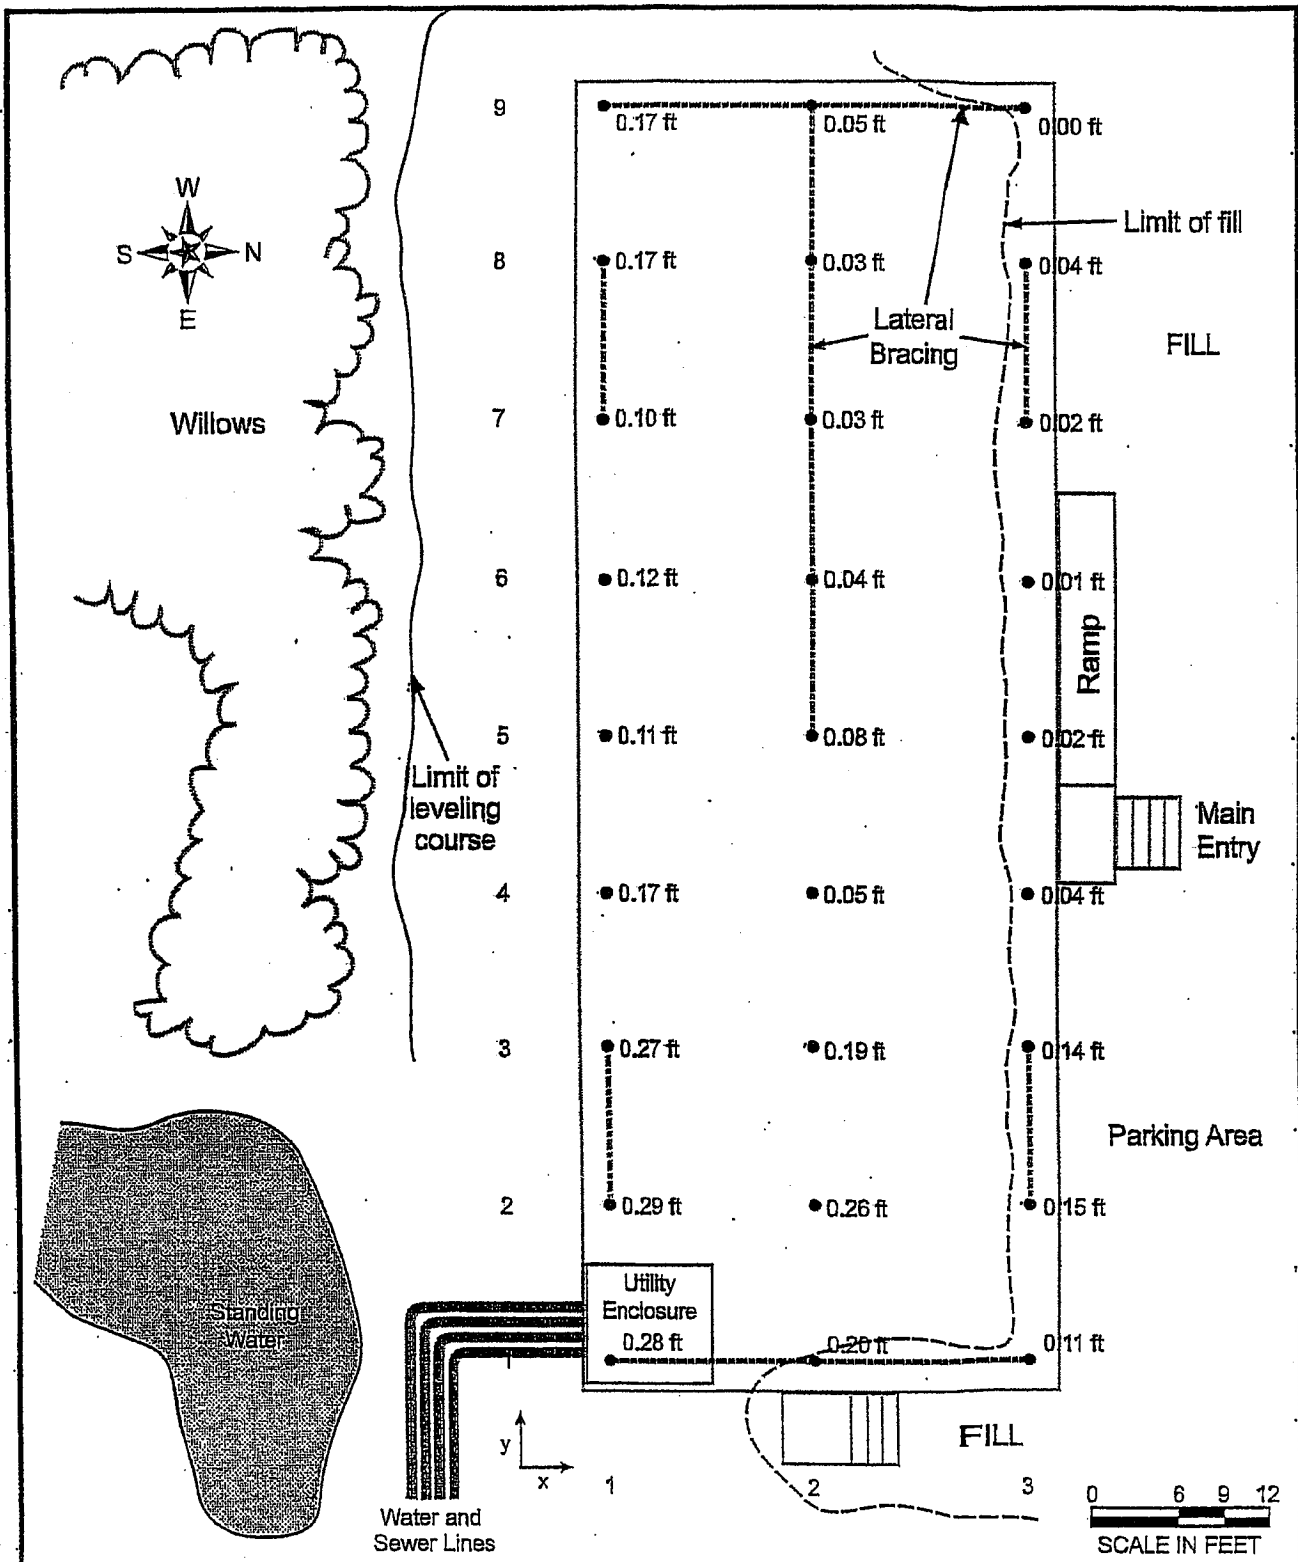
1

The survey results confirm variable displacements have occurred across the building. The distribution of individual pile displacements also closely matches the pattern seen from the data collected last fall. However, approximately one additional inch of displacement has occurred in the southeast corner and along the south perimeter piles relative to the northwest corner since the previous survey. The southeast corner is approximately 3 inches higher than the opposite (northwest) corner. The survey results are also shown on Plate 1.

In addition to the recommendations of provided in our initial report, the building should be leveled by a qualified contractor before the facility is placed in service.

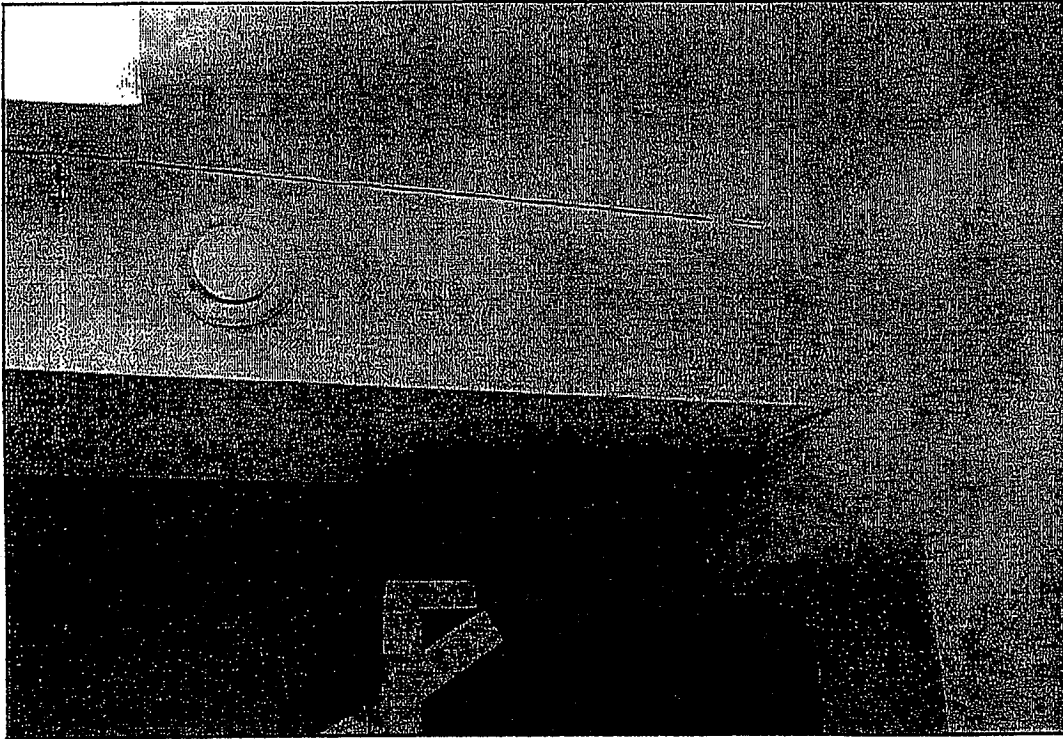
PHOTO 1. October 14, 2004: View of drywall damage at interior utility chase.

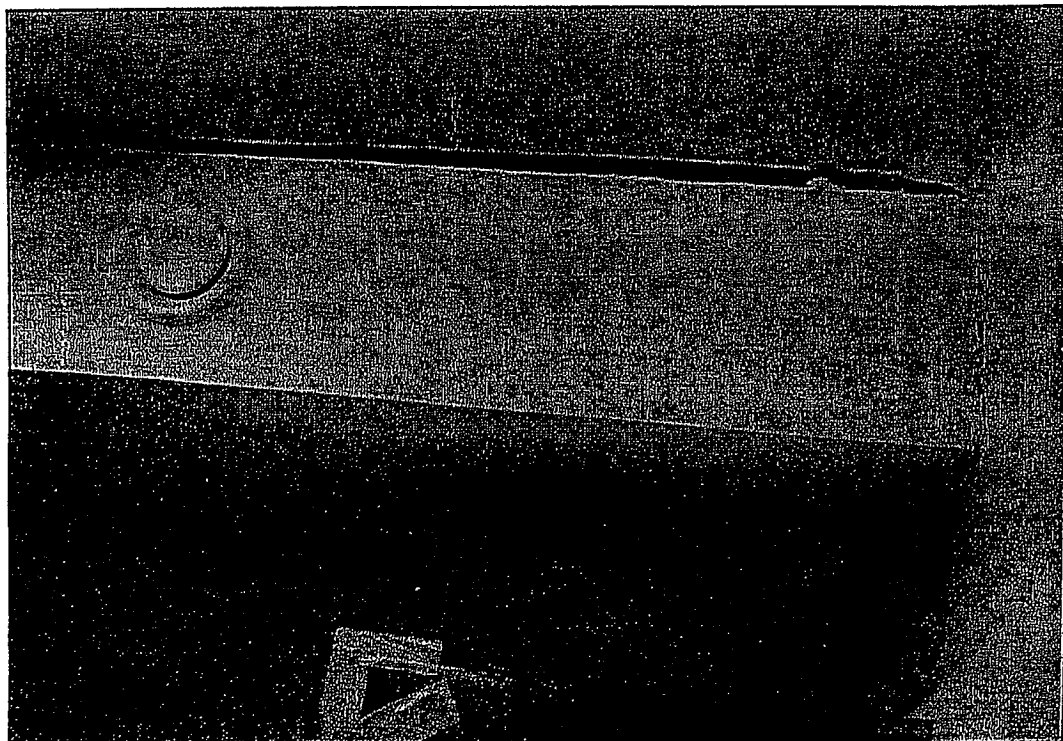
PHOTO 2. March 25, 2005: View of drywall damage at interior utility chase.

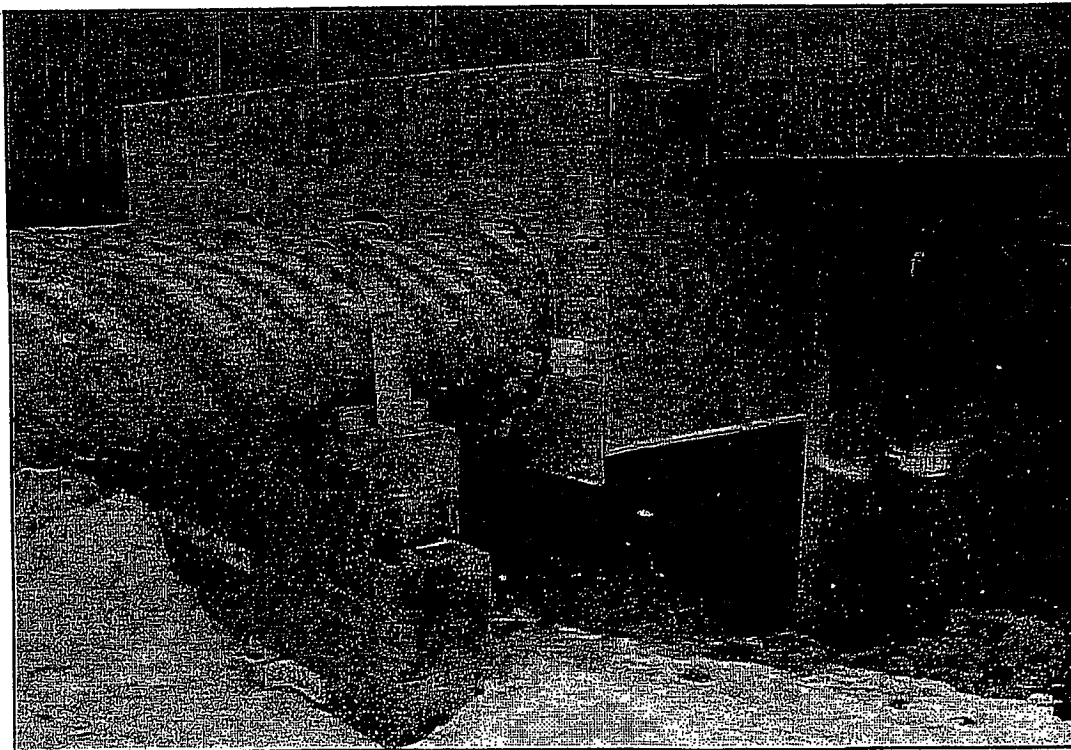
PHOTO 4. March 25, 2005: Arctic pipe enclosure damage (note large gap below bottom of pipes).
